Minerals Inspection Report

Mine Name: Lime Peak Quarries	Permit Number: M/49/0047	Mine Status: Inactive
Operator Name: Cheif Consolidated Mining Co.	Inspection Date: 09/07/2016	Permit Fees: Paid
Inspector(s): A. Abate, W. Western	Inspection Time: 10:00 AM	Bond Amount: \$115,600
Attendee(s): N/A	Weather: Clear 80s	Bond Escalation:
Inspection Purpose: Evaluate disturbance area for the purposes of reclamation		Prior Inspection: 6/17/2009

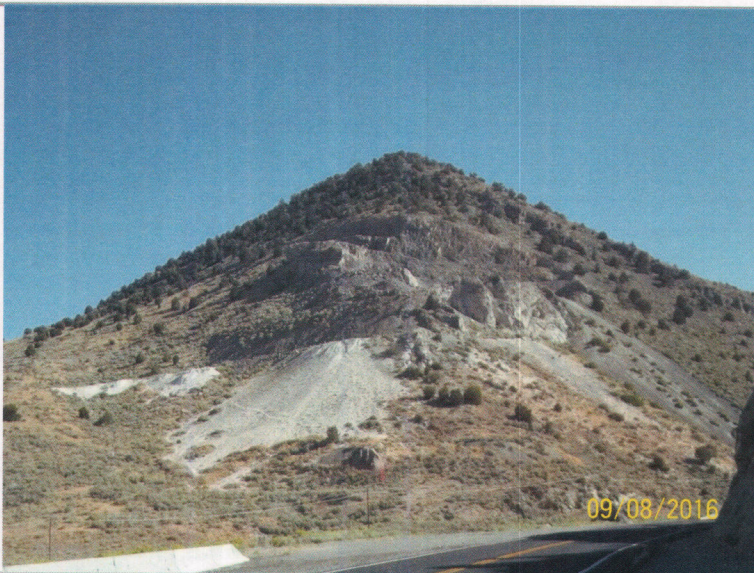
Overview from the highway of the Lime Peak Quarry from Highway 6.

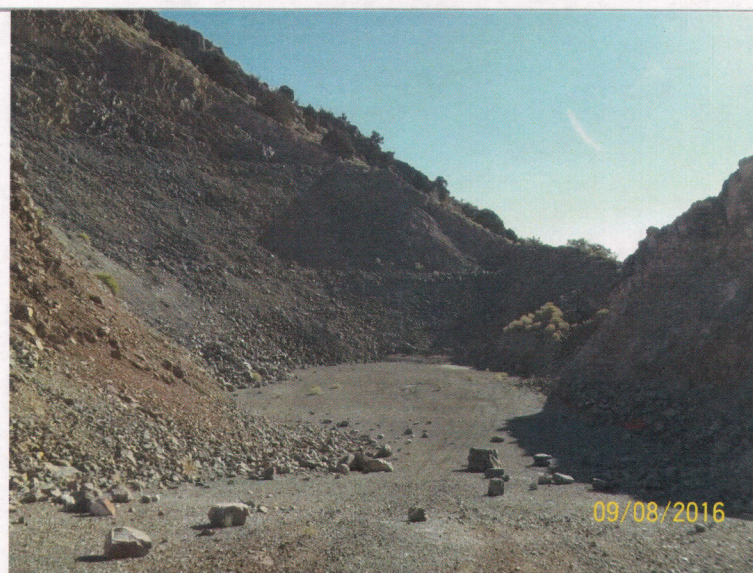
View from the entrance into the quarry looking into it.

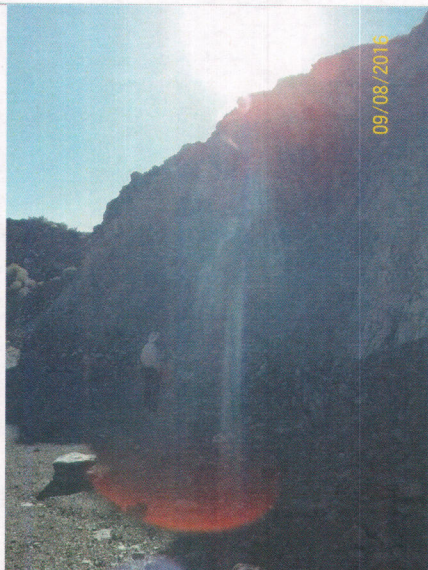
2. <i>Public Safety (shafts, adits, trash, signs, highwalls)</i>	<input checked="" type="checkbox"/>	<input type="checkbox"/>
The quarry is located on a steep hillside adjacent to Highway 6 near Eureka, Utah. A gated dirt access road leads to the open pit area of the quarry. The highwall area was inspected and appears to be oversteepened in some areas (see photos). Benches were noted in the uppermost portion of the quarry. Previous inspections had noted benches at approximately 70-75 when the mine was active. An access road appeared to be present to this area, although it did not appear that the road to this area was accessible to a vehicle. This area may require access by ATV only. No outbuildings or any type of structures were noted in the permit area. Some ruins at the base of the quarry that were old foundations that appeared to be pre-law.

6. <i>Reclamation</i>	<input checked="" type="checkbox"/>	<input type="checkbox"/>
According to previous inspection reports, the site has been partially reclaimed. A variance was granted for this permit allowing the mine to not be topsoil and seeded. Reclamation at this site will ultimately be a challenge due to accessibility issues and the steepness of the highwall. Backfilling inside the entire quarry will not be possible.

Observing the steep highwall inside the quarry.

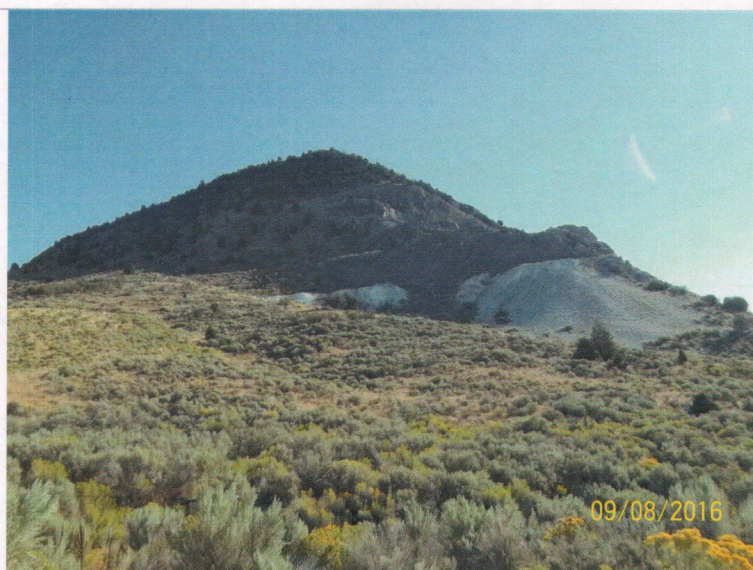
4. <i>Deleterious Material</i>	<input checked="" type="checkbox"/>	<input type="checkbox"/>
None observed. Mine dumps were noted on the outcrops of the road into the quarry. Some of these dumps appeared to be white in color, which likely is a colechified (CaCO ₃) soil.

Mine dump slopes were colechified but some vegetation was observed to be growing on the slopes

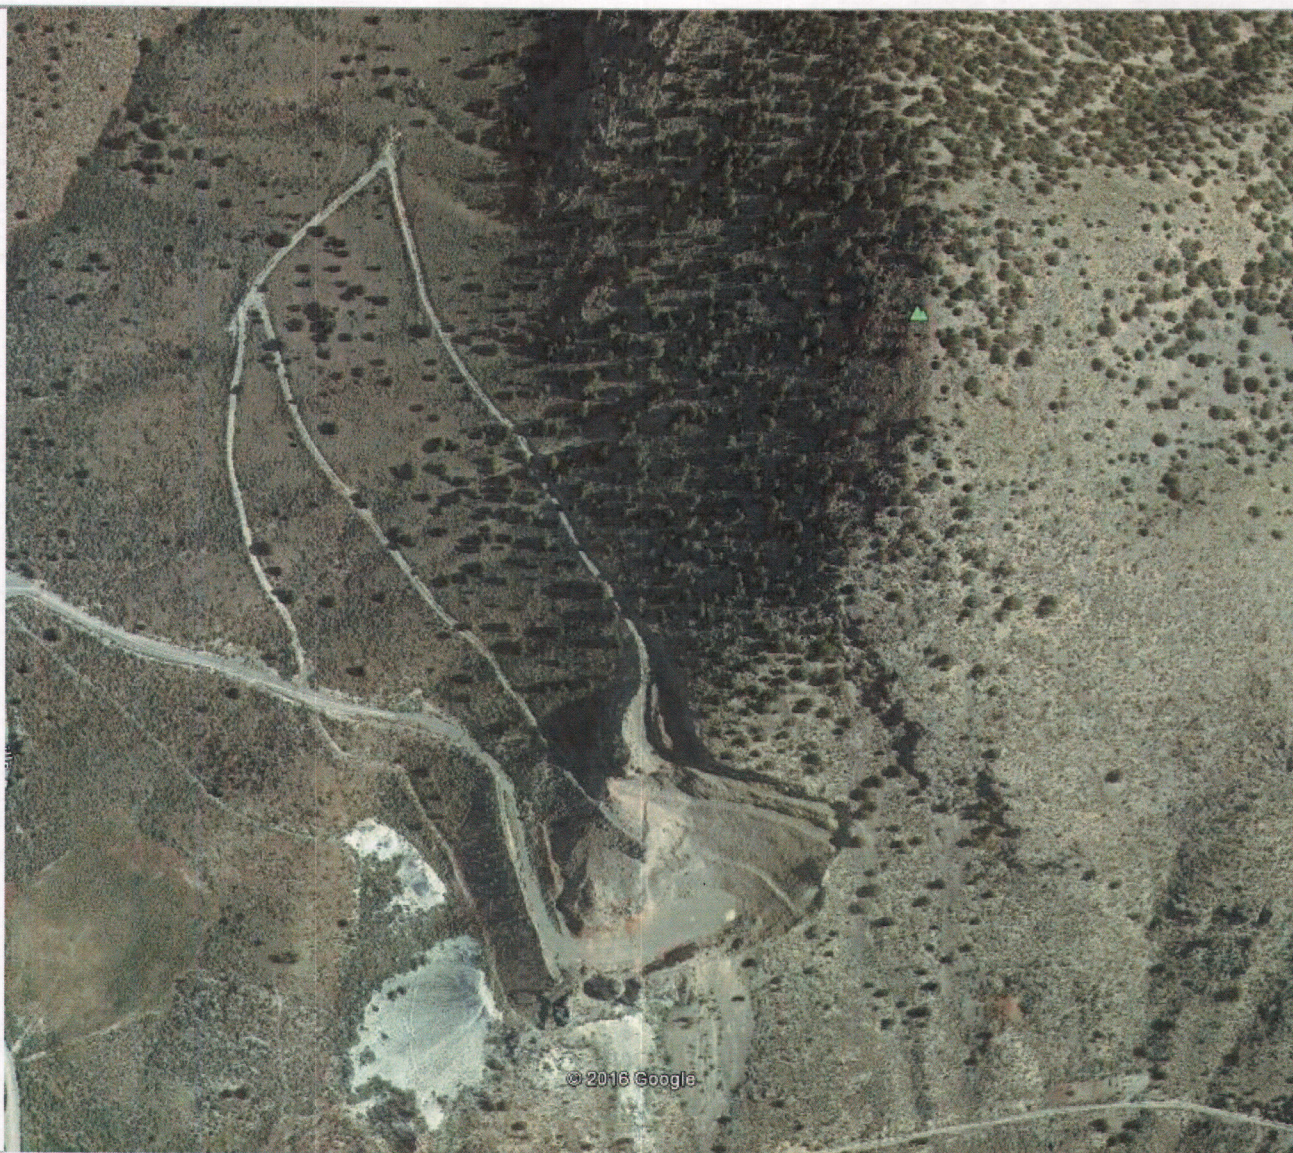
5. <i>Roads (maintenance, surfacing, dust control, safety)</i>	<input checked="" type="checkbox"/>	<input type="checkbox"/>
Three roads were created to access the upper bench levels of the quarry. The sole purpose of these roads was for quarry access and thus should be reclaimed at the appropriate time the mine is retired.

Aerial view of the quarry. As can be seen, several bench levels exist. The auxillary roads leading to the upper benches can be accessed by ATV only.
